Inspection Report

Property Address:
369 Sea Trail Way
Anytown NC 11111

Trident Pro Home Inspections, LLC

Date: 6/8/2025	Time: 09:00 AM	Report ID: Sample-001
Property: 369 Sea Trail Way Anytown NC 11111	Customer: John HomeBuyer	Real Estate Professional:

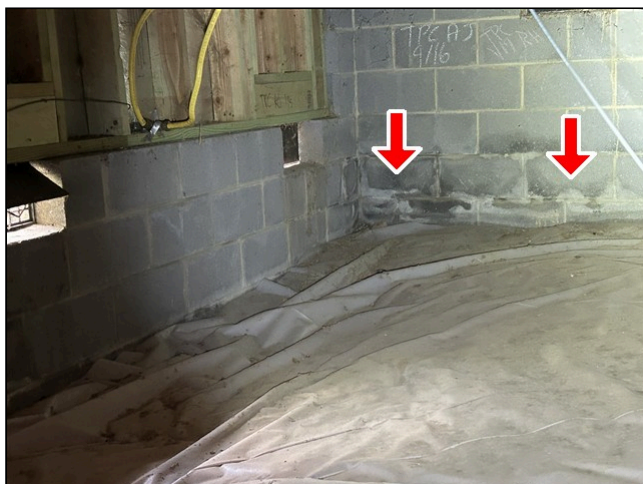
1.0 Item 1(Picture)

(1) White efflorescence (powder substance) on the masonry block foundation wall indicates moisture is in contact with masonry components. Contact a waterproofing contractor to further evaluate and determine what corrective measures may be needed.

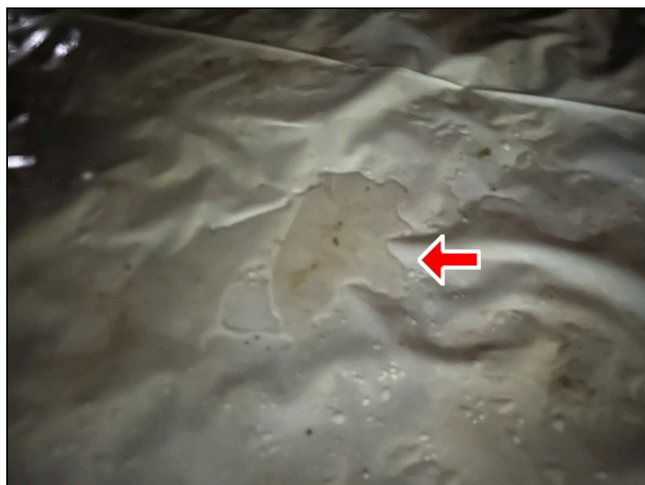
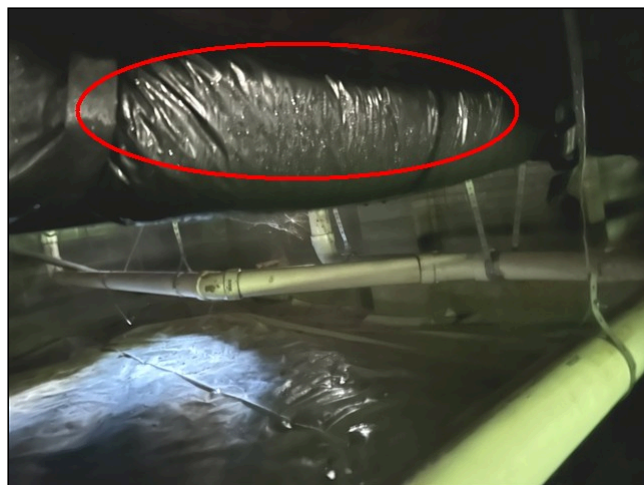
1.0 Item 2(Picture)

(2) Noted standing water in the crawl due to condensation from the HVAC ductwork. A waterproofing/drainage specialist should further investigate and repair to prevent water entry.

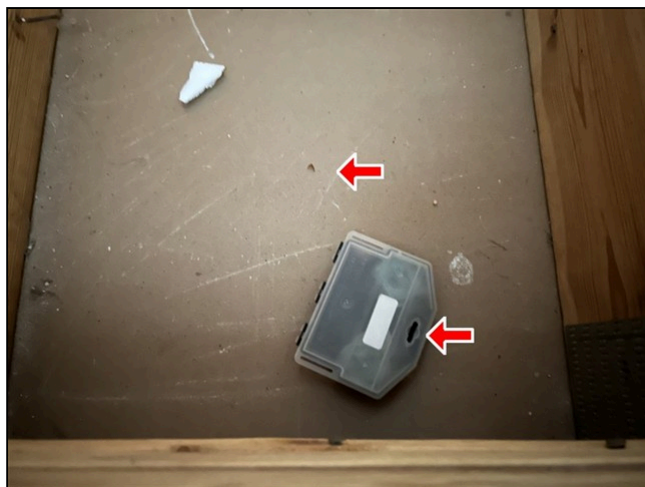
1.4 Item 1(Picture)

Noted evidence of vermin in the attic (feces and tunnels). Environmental concern. A pest removal contractor should further investigate.

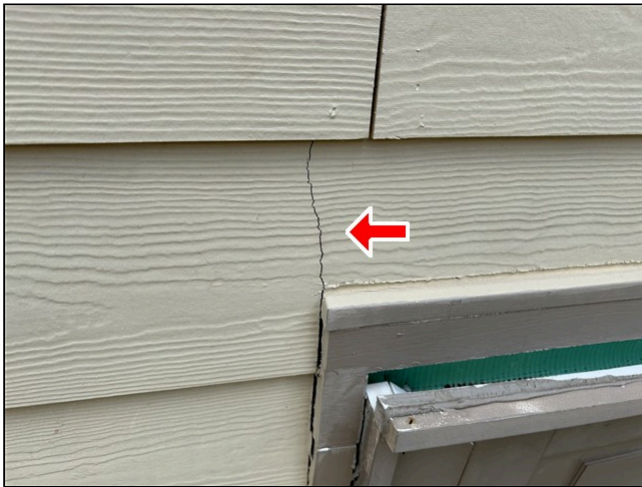
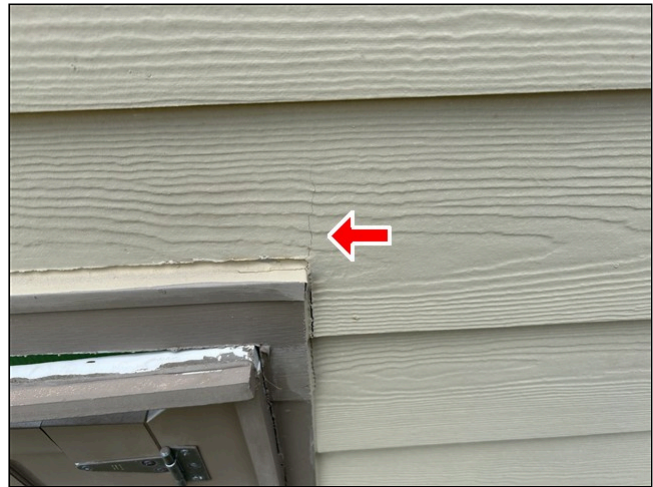
(1) Damaged siding at the following locations: right side of the structure. (the pictures may be a representative number). Water can enter through the damaged siding and cause deterioration of the adjacent framing components. A qualified contractor should repair or replace all damaged siding to prevent further deterioration and water entry.

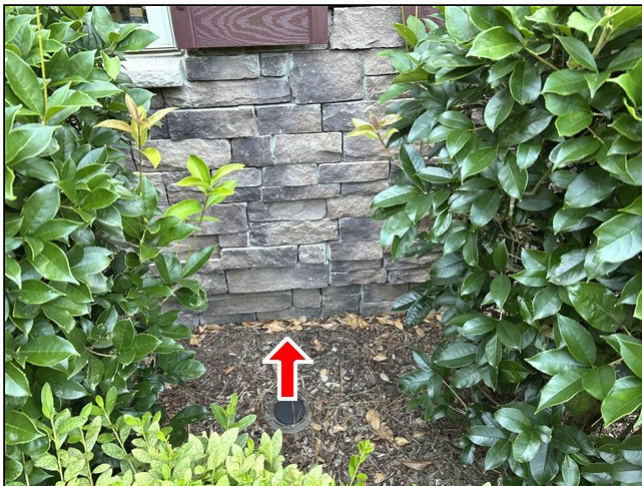
2.3 Item 3(Picture)

(2) The stone veneer is in direct contact with the ground and landscaping material. Refer to the manufacturer's specifications concerning this issue. The stone can separate from the wall when in direct contact with wet areas. A stone mason should further investigate and repair to prevent possible deterioration.

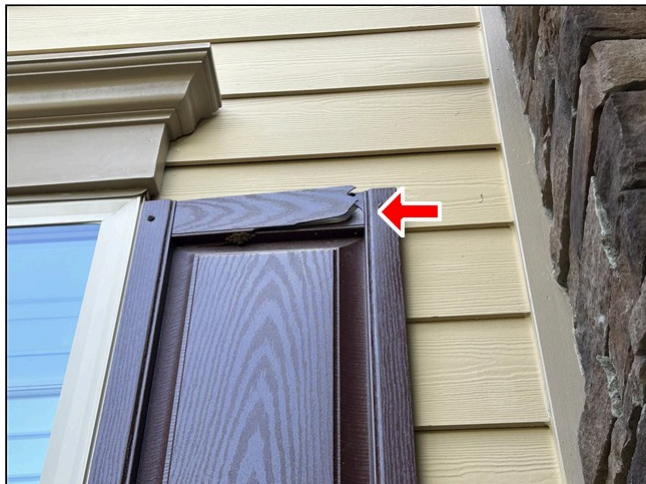
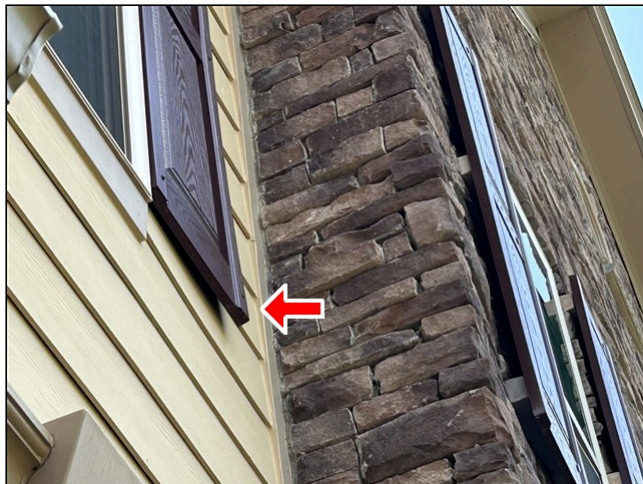
(3) Damaged/loose shutters on the front of the structure. A qualified contractor should further investigate and repair to prevent further deterioration.

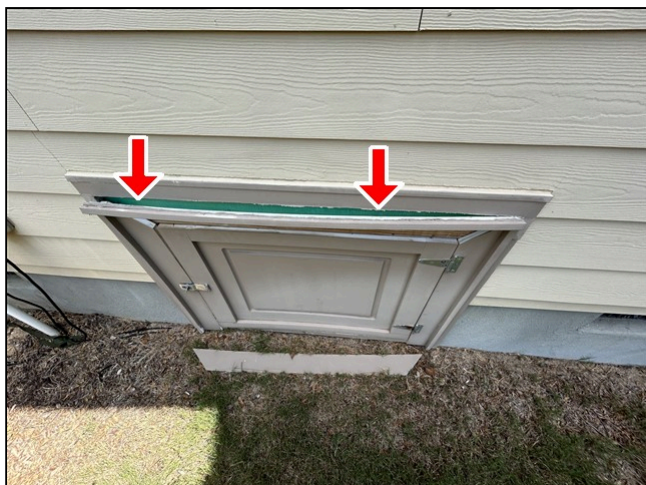
2.3 Item 6(Picture)

(4) Damaged trim at the crawl space entry door. A qualified contractor should further investigate and repair to prevent further deterioration.

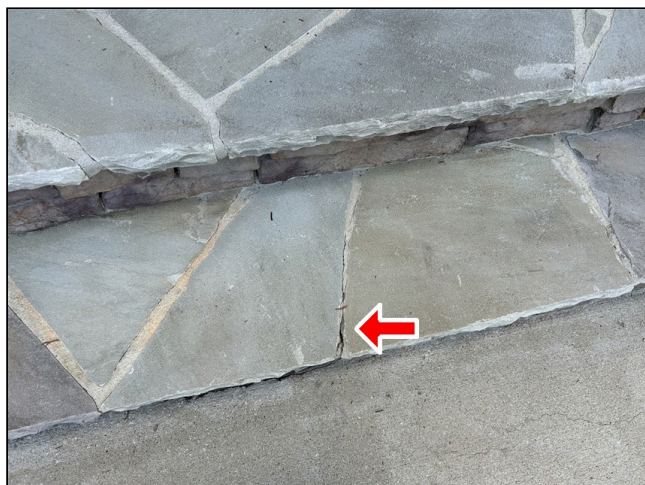
2.5 Item 1(Picture)

(1) Openings between the stone pavers on the front porch entry steps. A qualified contractor should further investigate and repair to prevent water entry.

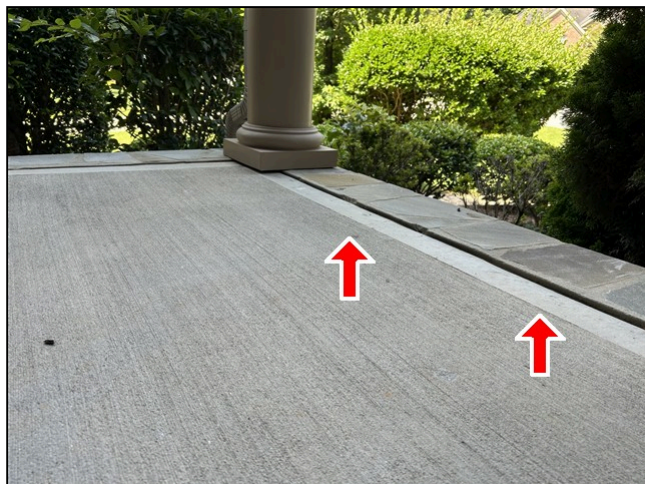
2.5 Item 2(Picture)

(2) The front porch concrete slab has recessed below the surrounding stone pavers. The fill material may have settled. A qualified contractor should further investigate and repair to prevent further deterioration.

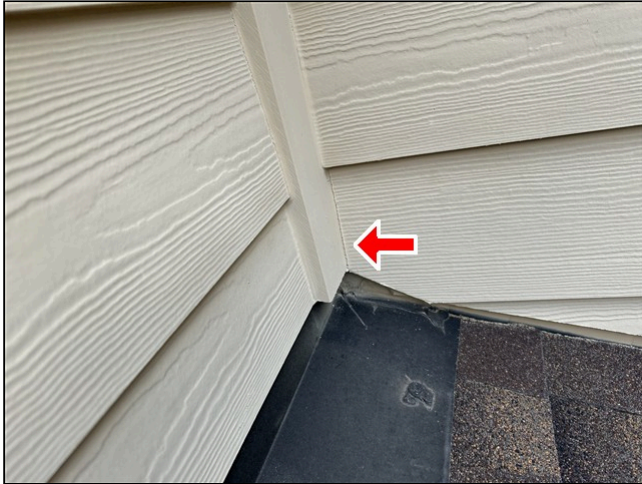
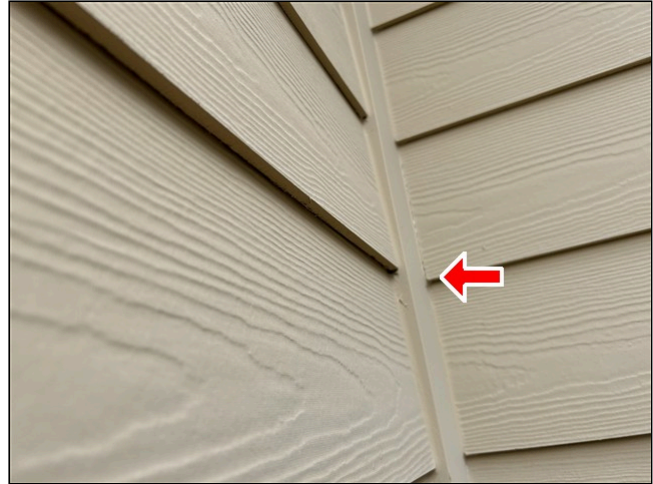
(1) Openings between the exterior siding and the vertical wood trim boards surrounding the structure. Seal openings with silicone to prevent vermin and water entry.

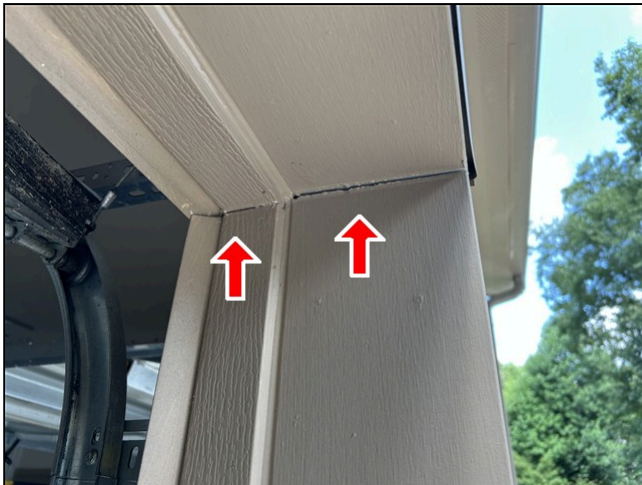
2.7 Item 3(Picture)

(2) Openings between the exterior trim joints (the pictures may be a representative number). A qualified contractor should further investigate and repair to prevent vermin and water entry.

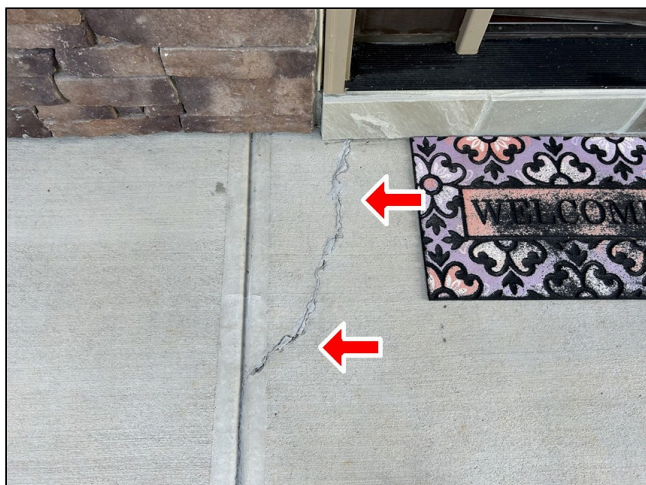
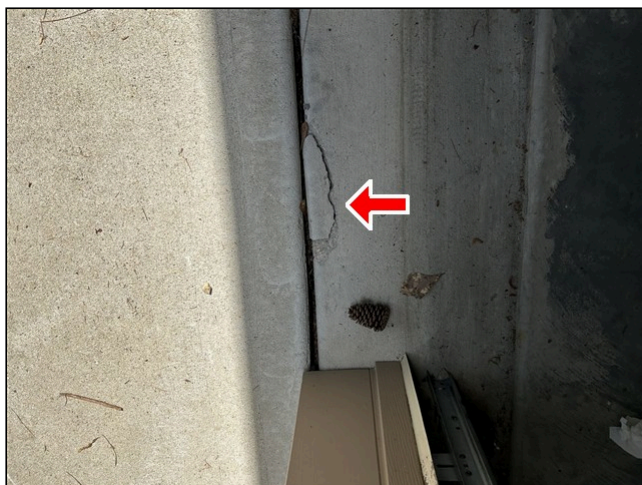
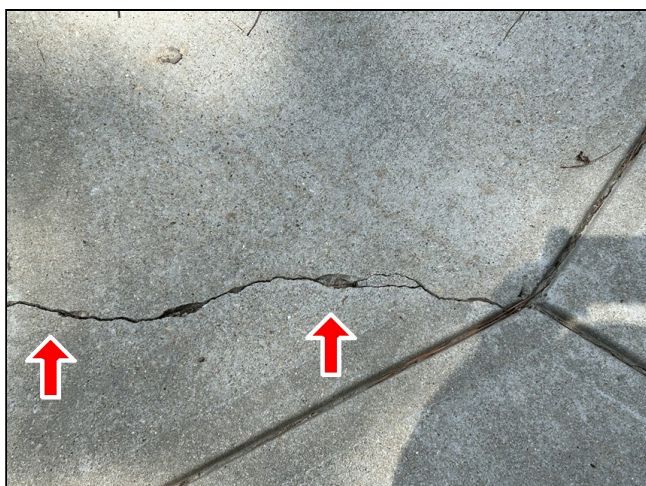
(1) Damaged concrete on the driveway, garage, and front porch slabs. Contact a concrete contractor for repair to prevent further deterioration.

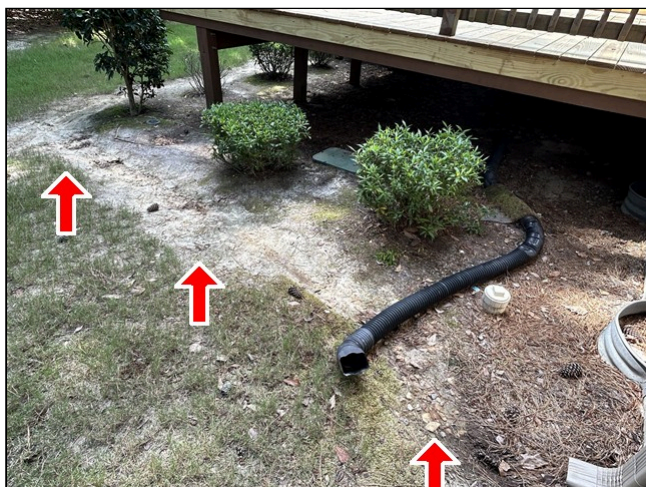
2.8 Item 4(Picture)

(2) The grade of the soil at the left rear of the structure appears to be inadequate. Evidence of missing soil was present in these areas. A landscaping contractor or drainage specialist should further investigate and repair to enable the water to exit away from the structure and to prevent further erosion.

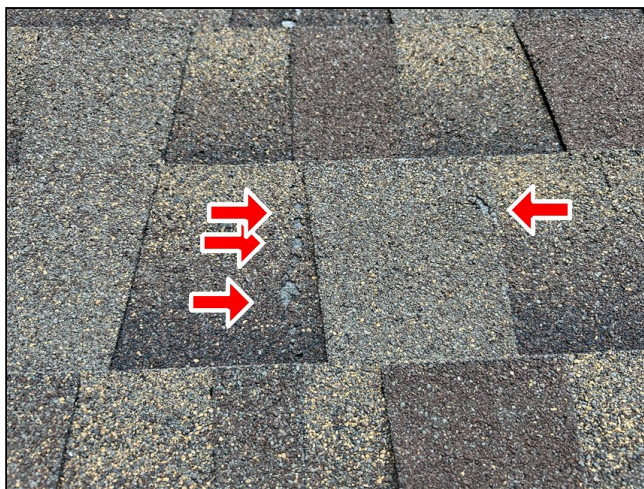
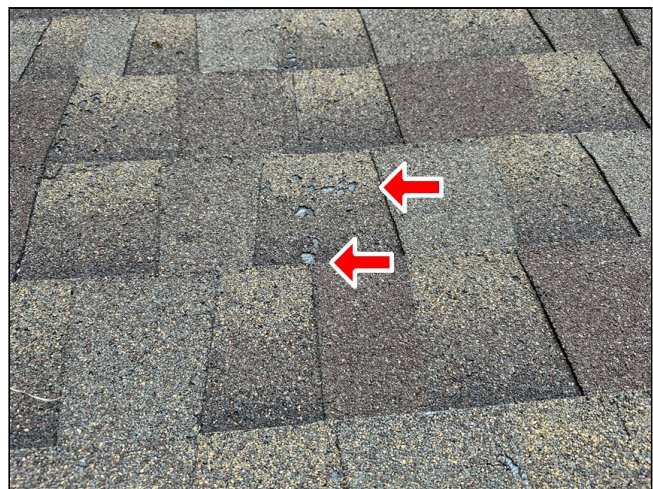
Damaged shingles (missing granules and visible fibers) at the following locations: rear of the structure. A qualified contractor should further investigate and repair to prevent water entry.

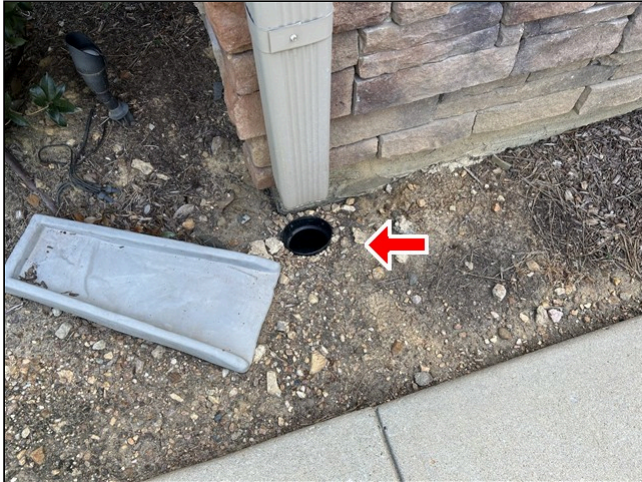
3.4 Item 1(Picture)

(1) The gutter downspouts are not attached to the drain pipes at the following locations: front and left rear of the structure. Repair to enable the water to exit away from the structure.

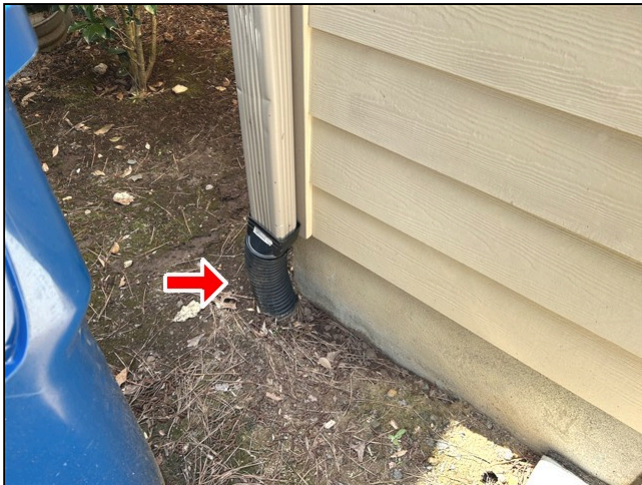
3.4 Item 2(Picture)

(2) The gutter downspouts empty into underground drain pipes. The inspector could not locate where the pipes terminate. Consult a qualified contractor for further investigation to ensure proper drainage.

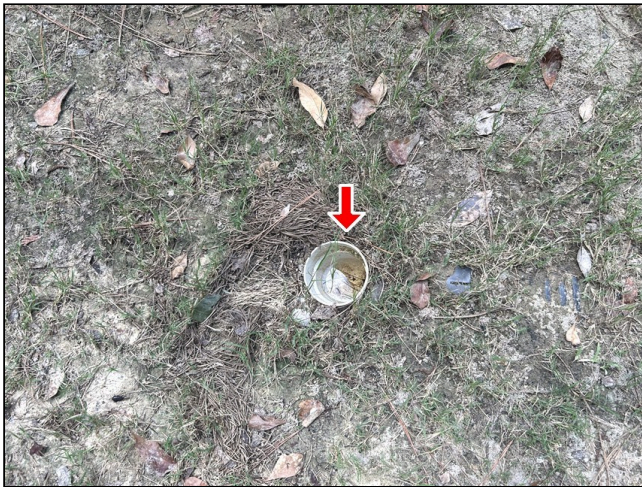
4.1 Item 1(Picture)

(1) Open PVC cover on the sewer drain line on the left side of the structure. Replace to prevent possible

bodily injury and to prevent sewer gases from exiting.

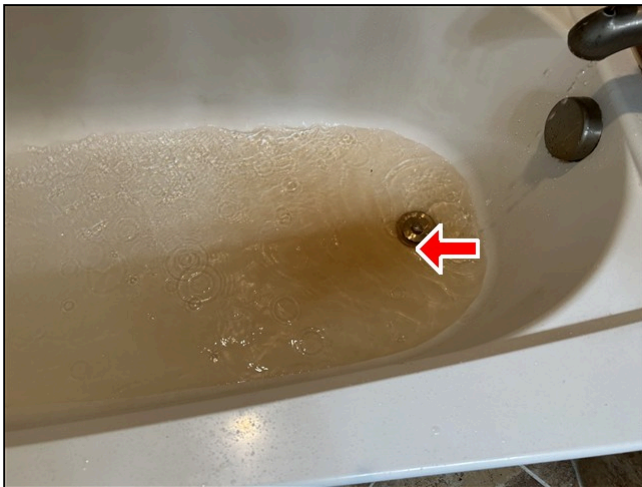
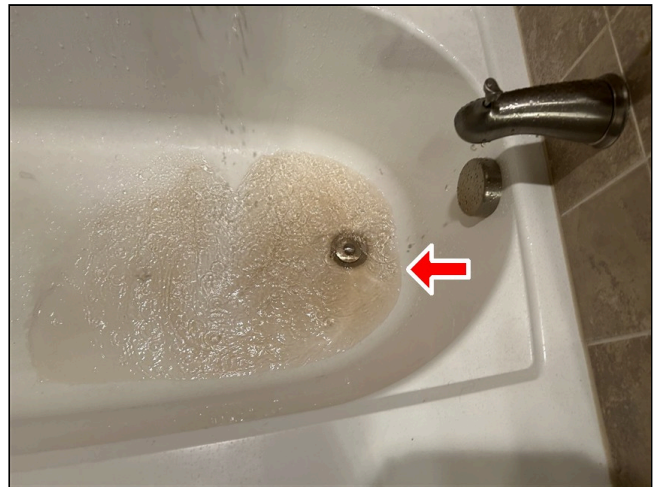
(1) Rust colored water exiting the hot side of the faucets. This is evidence of possible deterioration of the interior of the water heater. A licensed plumber should further investigate and repair.

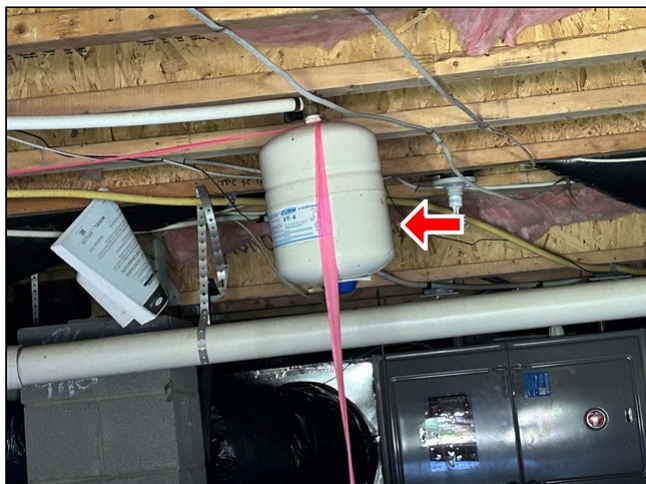
4.3 Item 3(Picture)

(2) The plumbing supply thermal expansion tank is not insulated. Thermal expansion tanks are required to be insulated where subjected to freezing temperatures in unconditioned spaces. A licensed plumber should further investigate and repair.

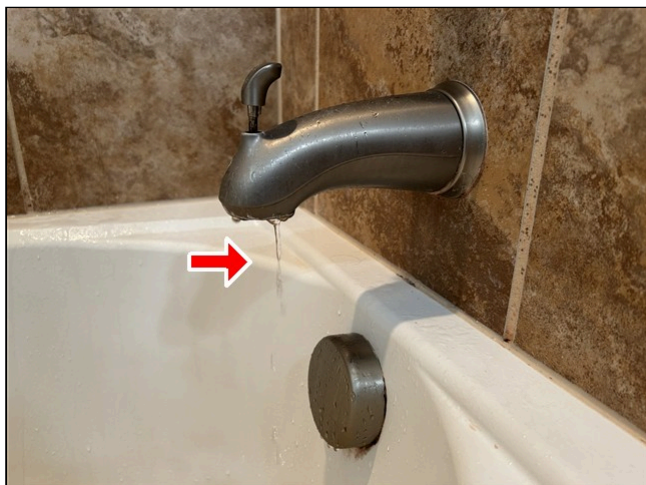
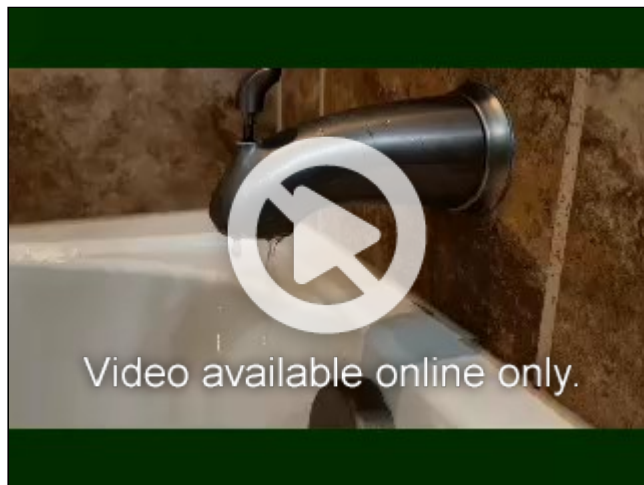
(1) Noted water leaking from the tub supply spout when the shower is activated in the right front guest bathroom. Water can possibly backflow into the wall cavity. A licensed plumber should further investigate and repair.

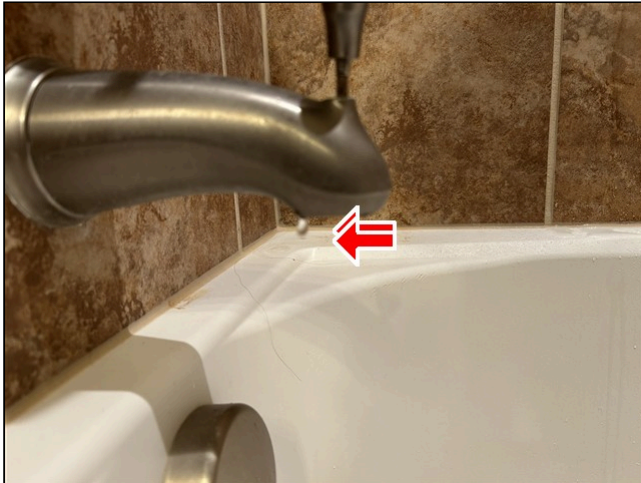
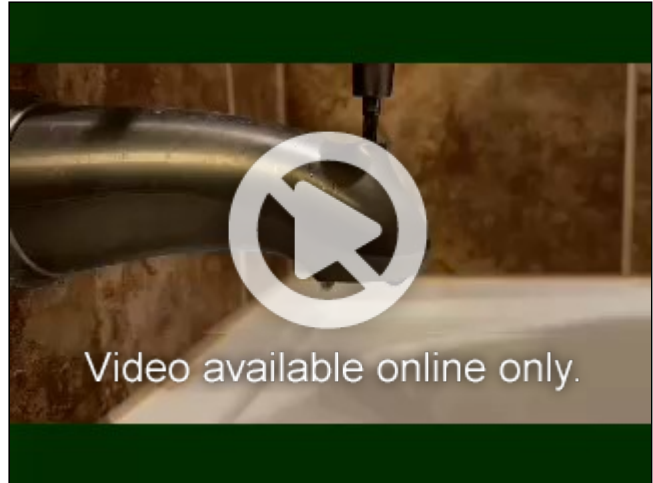
(2) Noted water leaking from the tub supply spout when the shower is activated in the second floor right rear guest bathroom. Water can possibly backflow into the wall cavity. A licensed plumber should further investigate and repair.

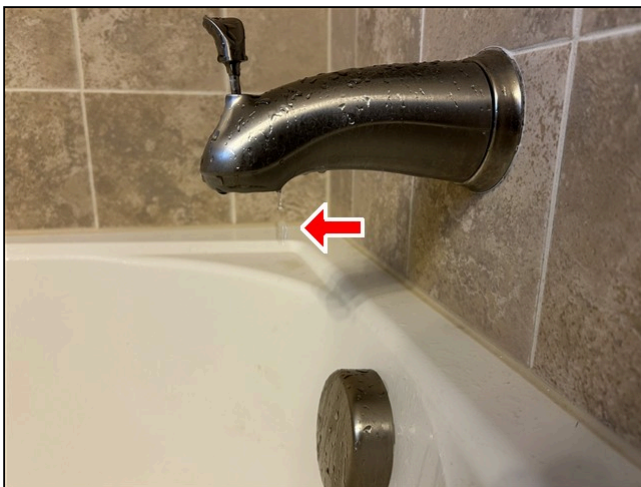
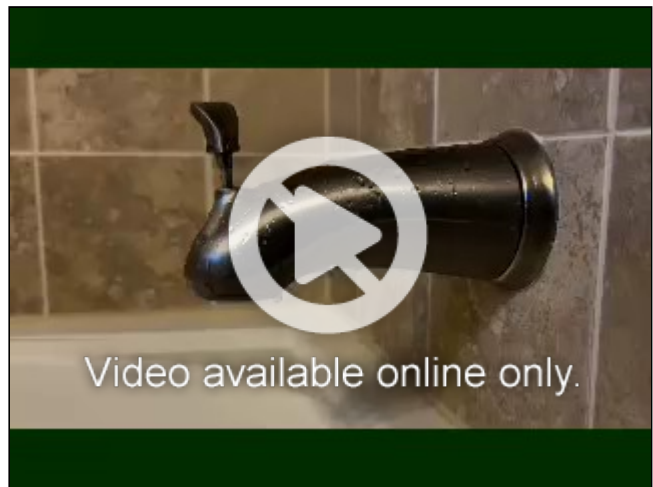
(3) Noted water leaking from the tub supply spout when the shower is activated in the second floor hall bathroom. Water can possibly backflow into the wall cavity. A licensed plumber should further investigate and repair to prevent further deterioration.

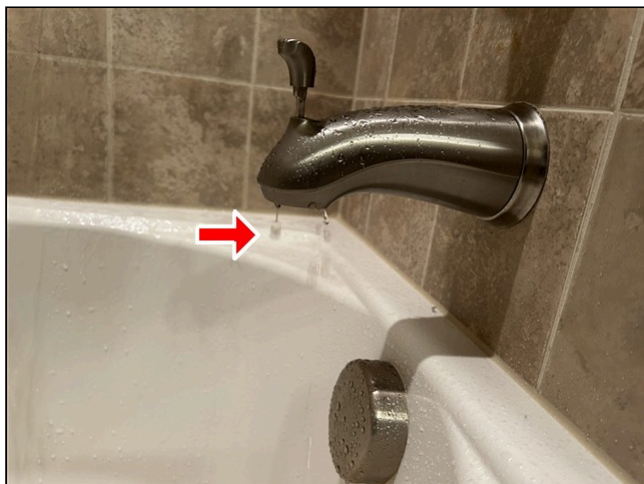
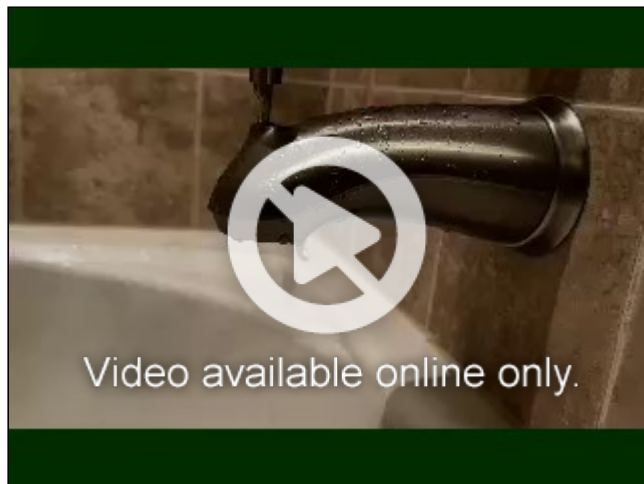
(4) Noted water leaking from the tub supply spout when the shower is activated in the first floor hall bathroom. Water can possibly backflow into the wall cavity. A licensed plumber should further investigate and repair.

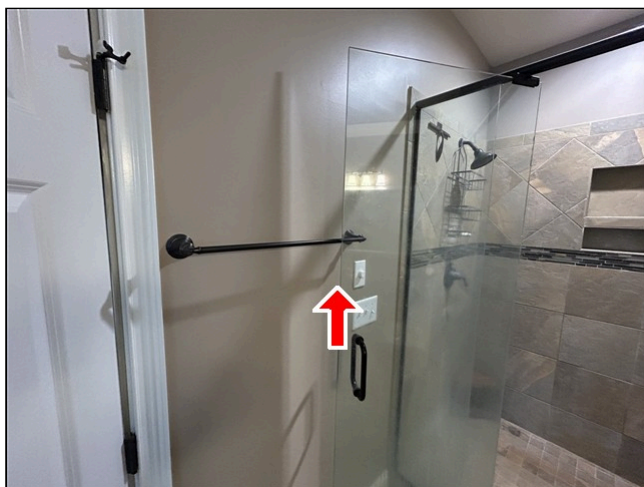
4.7 Item 1(Picture)

The master shower door strikes the towel bar when opened. A qualified contractor should further investigate and repair to prevent damage to the door and the bar.

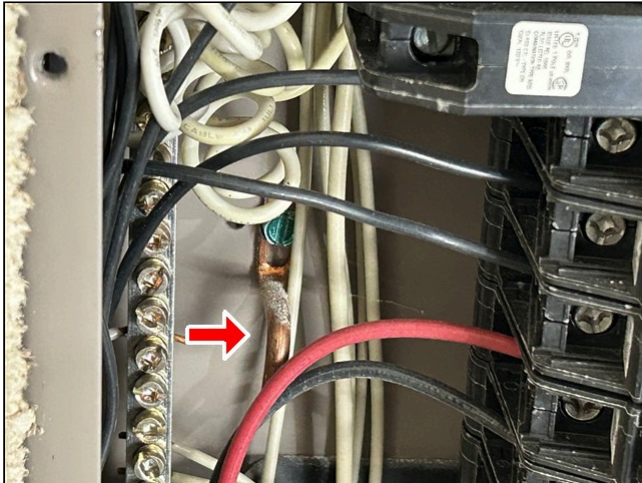
5.0 Item 1(Picture)

(1) Noted the electrical sub panel in the garage is not bonded to the metal panel. The bonding strap is loose and not attached to the buss bar. Electrical hazard. A licensed electrician should further investigate and repair.

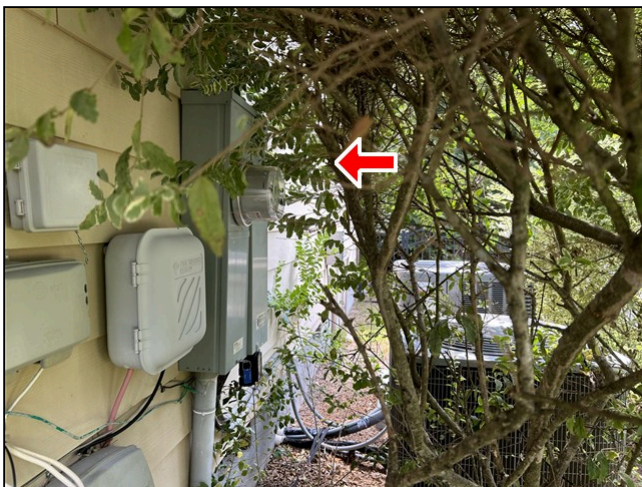
5.0 Item 2(Picture)

(2) The main electrical panel was blocked by overgrown bushes and the interior cover could not be removed. The interior of the panel was not inspected. Recommend trimming bushes to allow a minimum of 36 inches of clearance surrounding the panel to allow for inspection and maintenance.

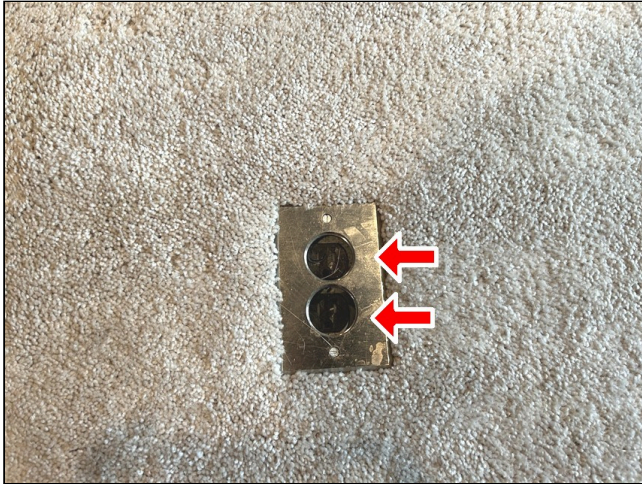
5.3 Item 1(Picture)

(1) Missing screw-in covers on the floor receptacles at the following locations: bonus room. A licensed electrician should further investigate and repair to prevent debris and water entry.

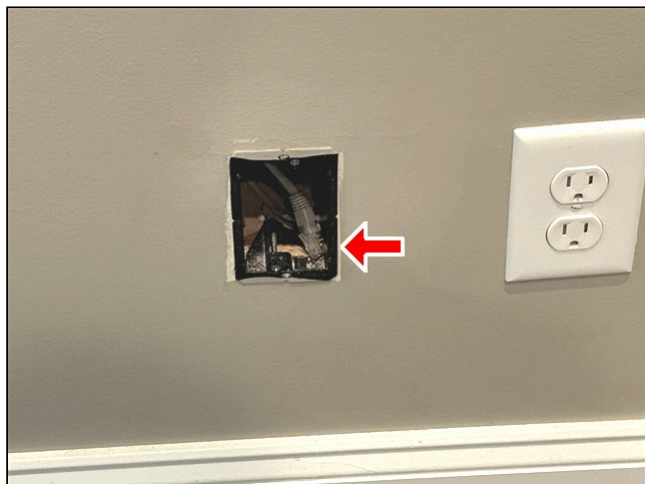
5.3 Item 3(Picture)

(3) Open electrical junction boxes at the following locations: office right wall. Electrical hazard. All electrical connections should terminate in a junction box with a cover. A licensed electrician should further investigate and repair.

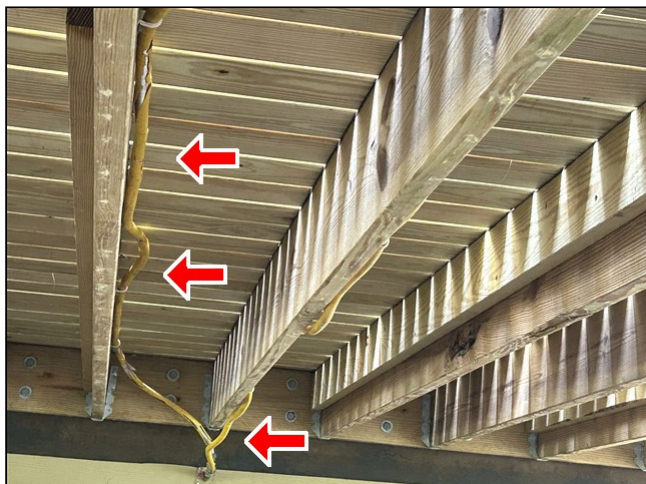
6.3 Item 1(Picture)

(1) The flexible yellow CSST gas supply line is exposed to the exterior. These lines were not intended for exterior usage. Safety hazard. A licensed HVAC mechanical contractor should further investigate to determine if the line is installed to manufacturer's specifications.

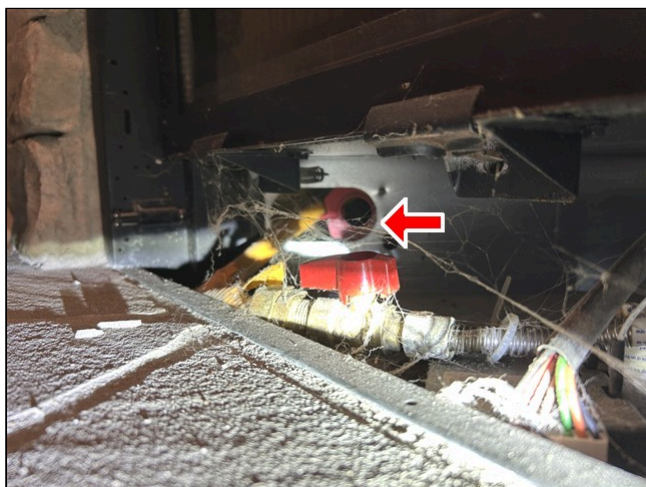
6.6 Item 1(Picture)

Opening surrounding the gas supply line below the fireplace. A qualified contractor should further investigate and repair to prevent heating/cooling loss and vermin entry.

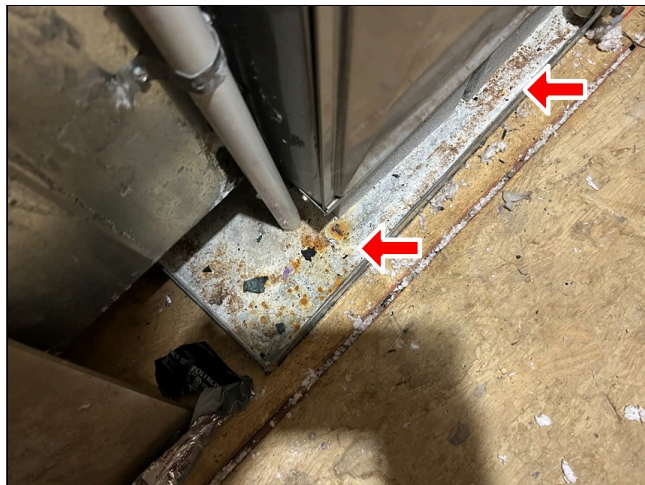
7.4 Item 1(Picture)

Noted rust in the over flow pan below the second floor HVAC air handler. The rust is evidence of condensation exiting the lower edge of the unit or the secondary condensation line. A licensed HVAC mechanical contractor should further investigate and repair.

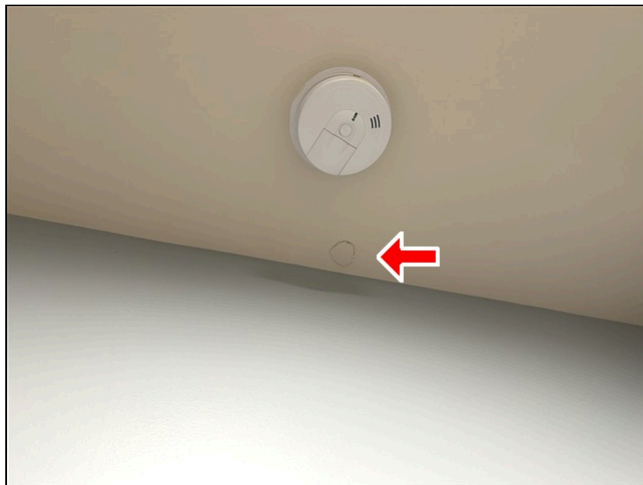
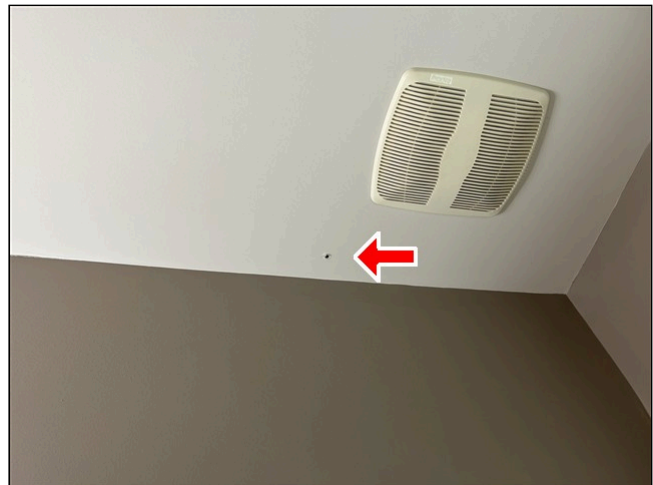
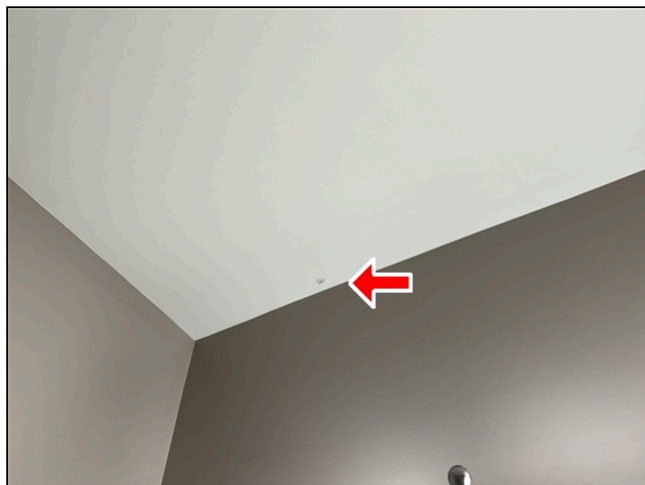
Noted nails protruding from the ceiling at several locations. Not considered a structural issue. A qualified contractor should further investigate and repair to prevent further deterioration.

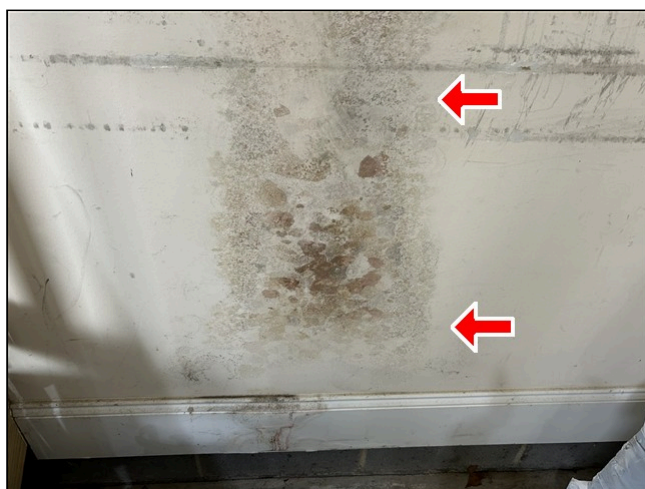
8.2 Item 1(Picture)

Evidence of an organic growth is present on the walls at the following locations: garage rear wall. This evidence is due to possibly higher than typical moisture levels. We did not inspect, test or determine if this growth is or is not a health hazard. A certified mold specialist should further investigate and determine the method of removal.

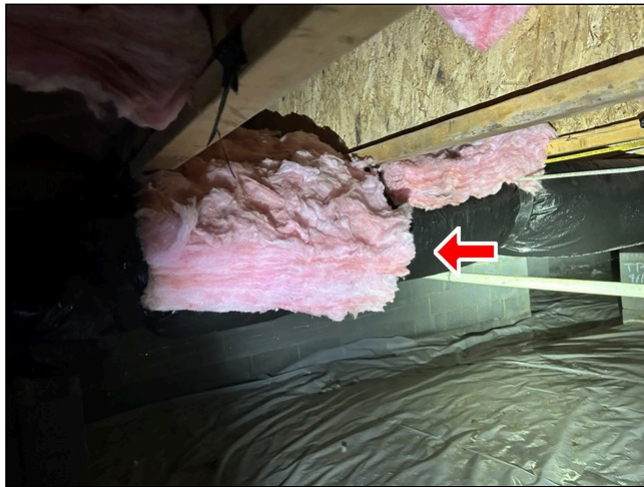
9.0 Item 1(Picture)

(1) Loose sections of insulation in the crawl space. A qualified contractor should further investigate and replace and secure the insulation to prevent heating/cooling loss.

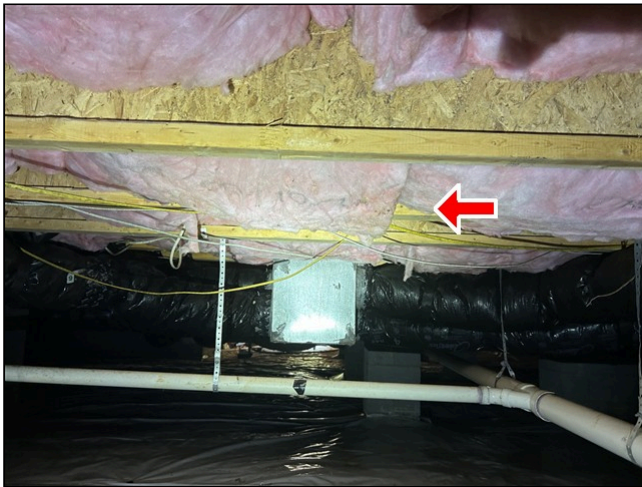
9.0 Item 2(Picture)

(2) The insulation has been installed on the lower edges of the engineered floor I-beams. The insulation should be in direct contact with the floor sheathing. The air gap between the floor sheathing and insulation reduces the R-value of the floor system and traps moisture. An insulation contractor should further investigate and repair.

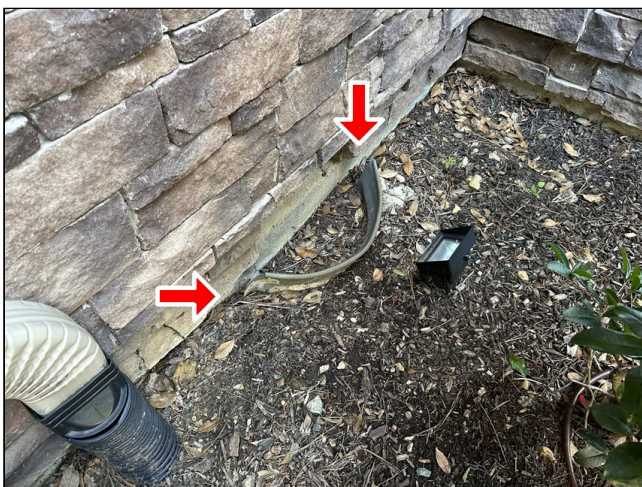
9.1 Item 1(Picture)

The half moon diverters at the foundation vents on the front of the structure are not flush with the foundation wall and may allow water to enter the crawl space. Repair to prevent water entry and further deterioration.
